Repair and Hardening of Mid-Atlantic Ocean Observing Assets After Hurricane Sandy

NOAA Award No. NA14NOS4830003

Report 04: 30 September 2014

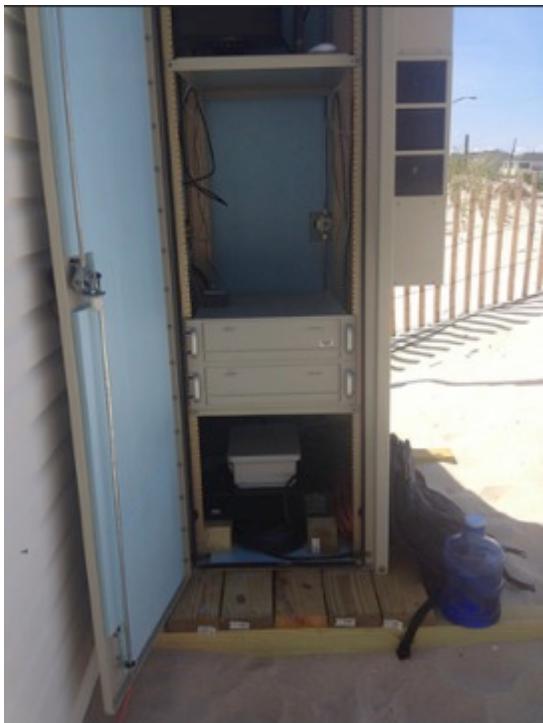
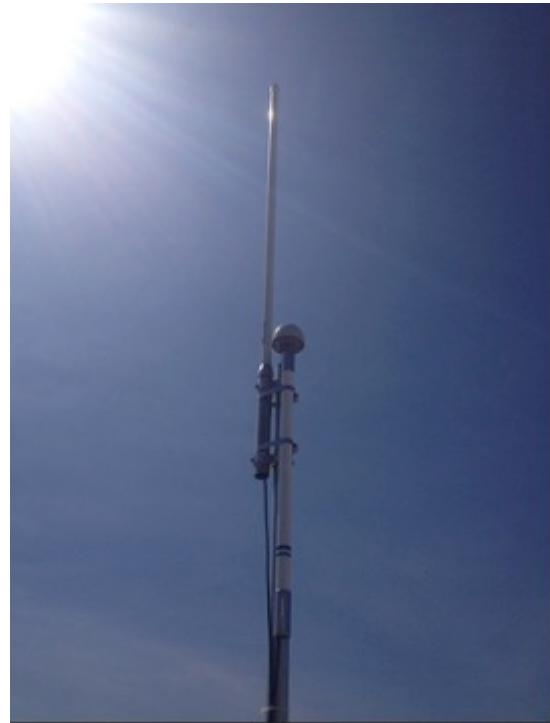
1. Seaside Park, NJ (SPRK)

1. Installation of full 13 MHz system in Seaside Park, NJ (SPRK)
2. Installation of full 25 MHz system in Port Monmouth, NJ (PORT)
3. Installation of 13 MHz combined transmit/receive antenna in Brant Beach, NJ (BRNT) and Brigantine, NJ (BRMR).
4. Installation of 25 MHz combined transmit/receive antenna in Staten Island, NY (SILD).
5. Continued efforts in dual transmit upgrade at LOVE.
6. AIS-pattern generation software installed on sites: SPRK, BRNT, BRMR, SILD, HOOK, and HOMR.
7. Data analysis and QA/QC checks of SPRK, PORT, BRNT, BRMR, and SILD.
8. Different methods of antenna calibrations.

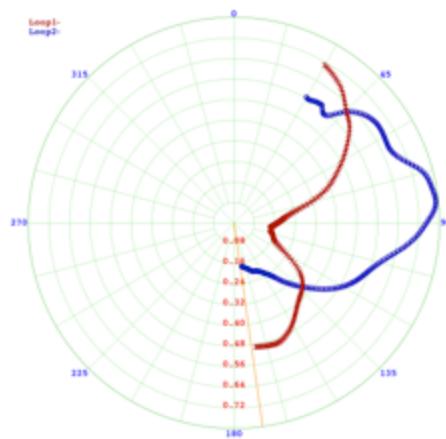
1. SPRK

a. This beach is a popular spot for the summer so we relied on the AIS equipment to assist in an antenna pattern measurement. After more than a week of vessel hits, we generated this pattern:

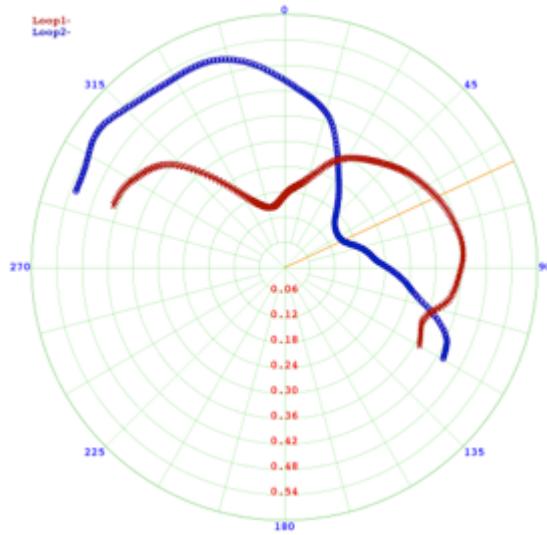
a. A walking antenna pattern measurement was performed with the new site equipment on August 19th, 2014. Below is the measured pattern:

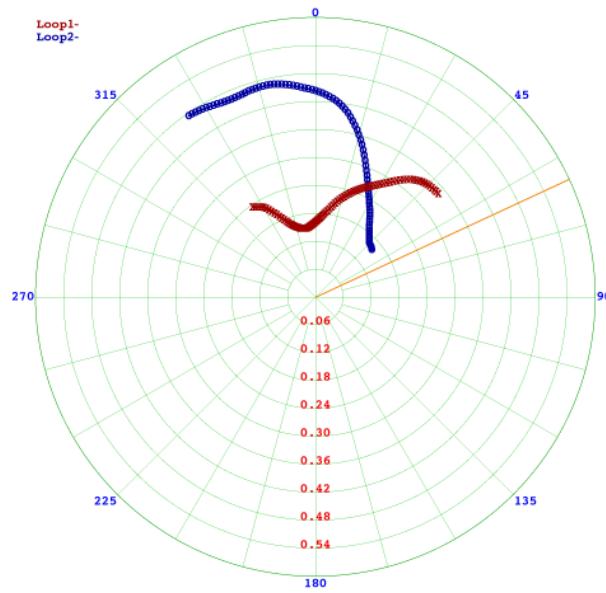
b. A boat calibration was also performed on August 28th, 2014. Below is the measured pattern:

The boat pattern measurement was difficult to perform because the boat was not able to move the transponder close to shore with the shallow bathymetry. This is seen as the measurement for loop 1 stops at 45 degree bearing while the walking pattern extends to 120 degree bearing.

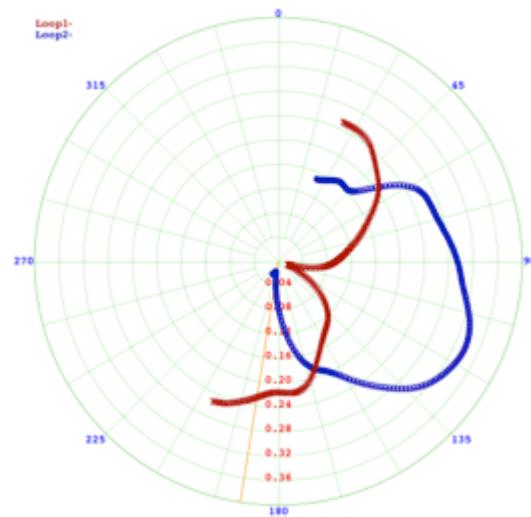
a. A walking antenna pattern measurement was performed on October 1st, 2014. The measured pattern is displayed below:

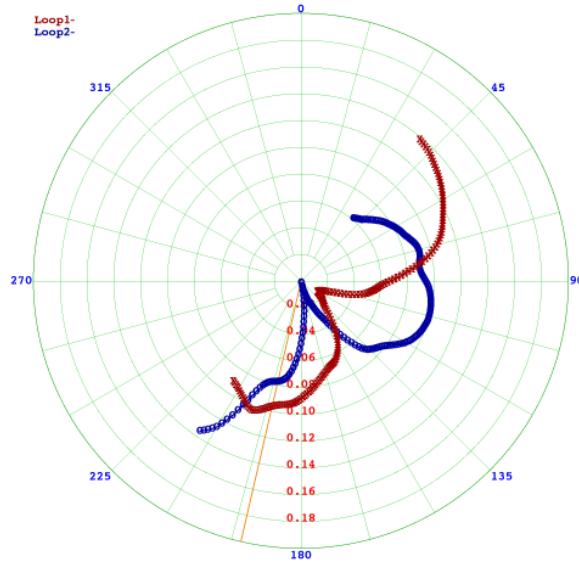
a. A walking antenna pattern calibration was performed on August 26th, 2014 and is displayed below:

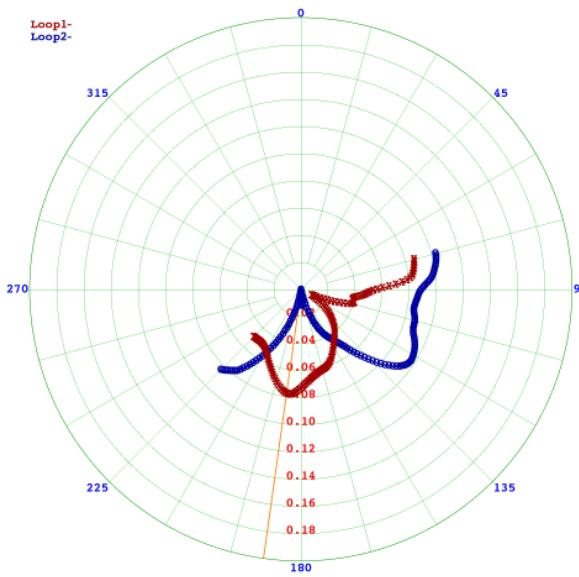
b. Another pattern was measured using the AIS software package and is currently installed in the configurations folder on site:

For a period of time, the AIS pattern-generation software was not working properly and this problem was reported to CODAR via phone call on September 19th, 2014. There was an issue with the webserver agent starting up on the daily computer

reboot. The fix has since been implemented on this site (as well as all other sites running AIS pattern-generation software).

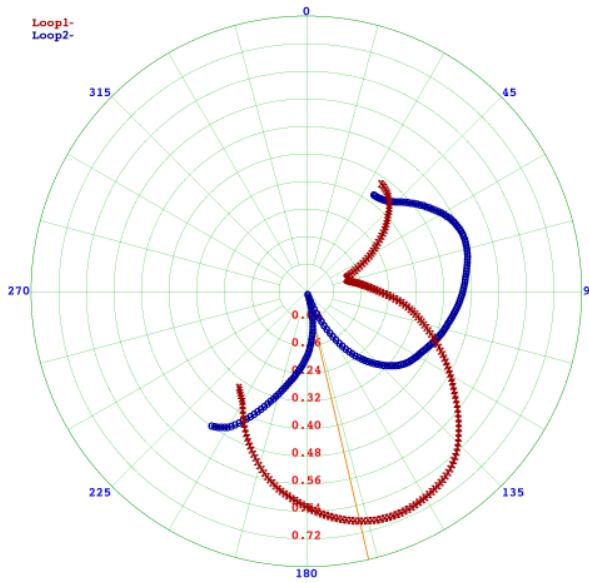
a. A walking antenna pattern measurement was performed on August 26th, 2014 after the new antenna installations. The pattern is displayed below:

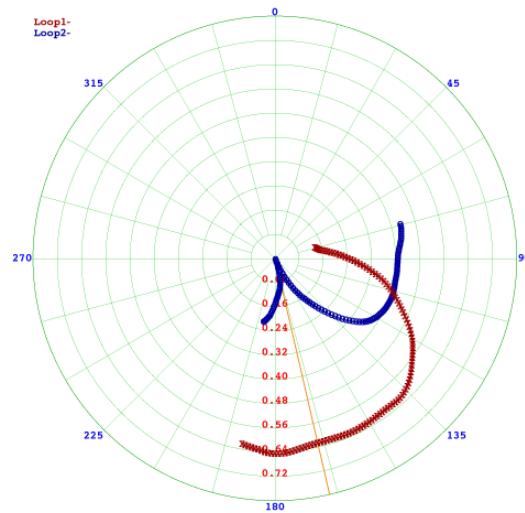
b. Two days later (August 28th, 2014), a boat pattern measurement was performed:

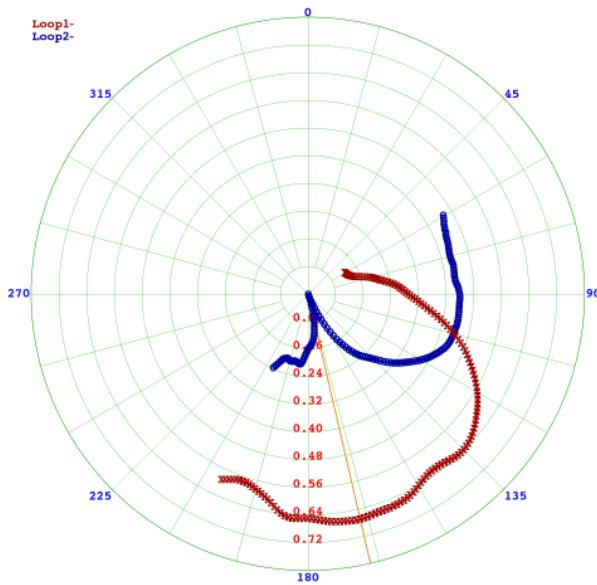
c. We also measured a pattern with the AIS software on August 20th, 2014.

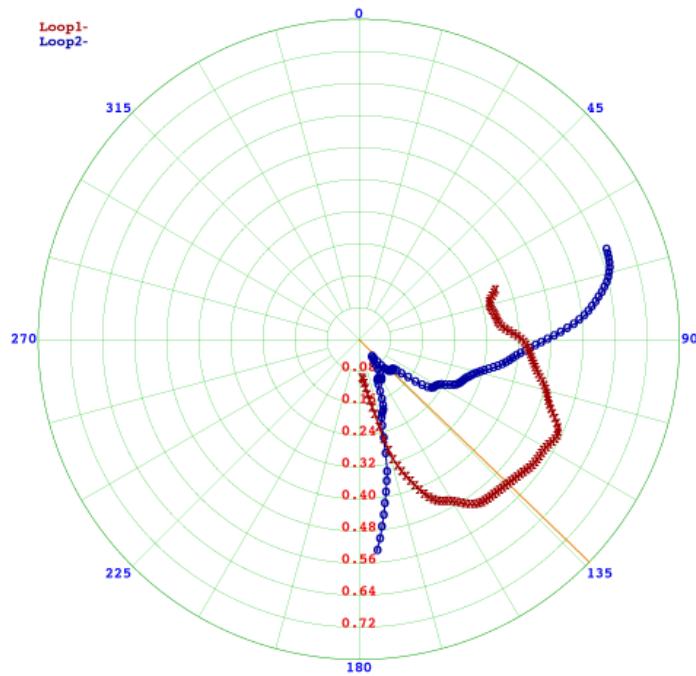
An AIS-generated pattern was installed on September 2nd, 2014 after the installation of the new dual transmit equipment. Although the installation was completed in the previous quarter, an antenna pattern wasn't measured until this quarter. The following figure displays the current AIS-generated pattern installed on site:

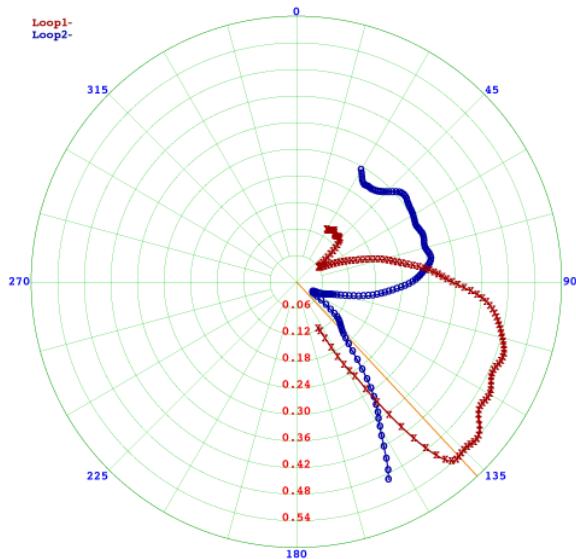
An AIS-generated pattern was measured for the 13 MHz site in Sandy Hook, NJ on August 12th, 2014. HOMR previously had a walking pattern measurement executed in a previous quarter and the AIS-generated pattern is currently installed on site. Below shows the pattern:

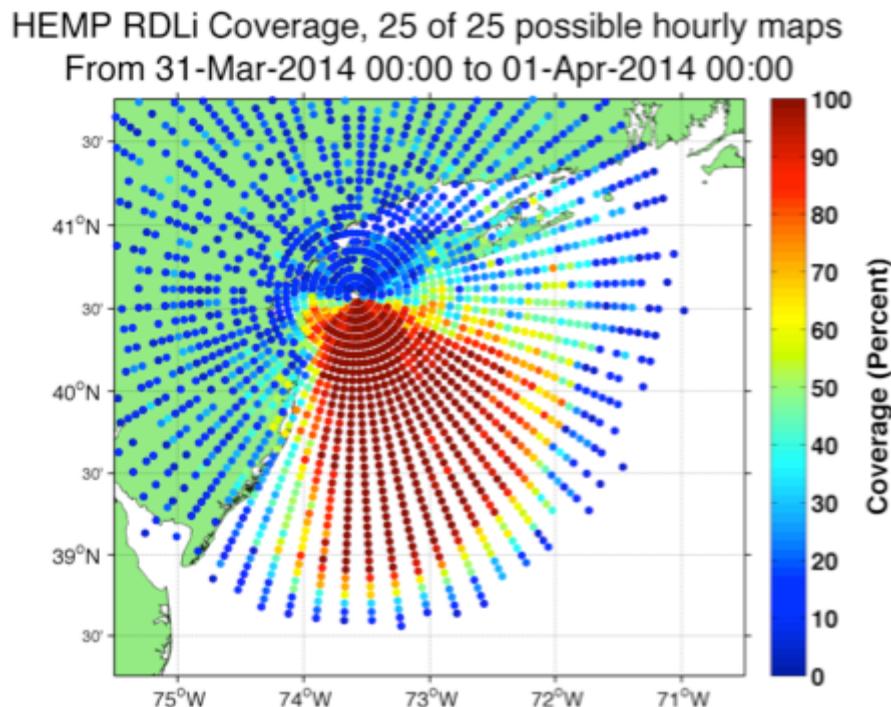
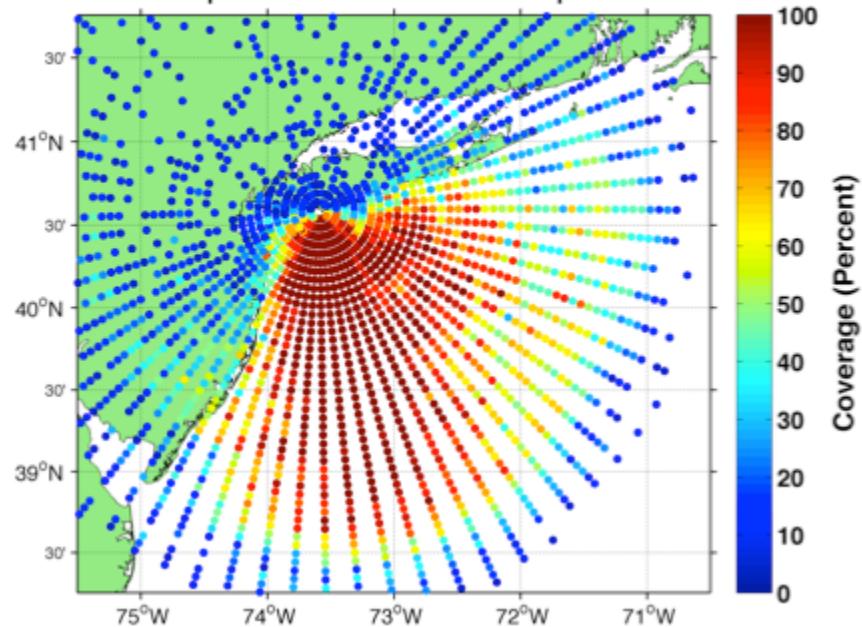
HEMP RDLi Coverage, 25 of 25 possible hourly maps
From 22-Sep-2014 00:00 to 23-Sep-2014 00:00

The purpose of the dual transmit upgrade at HEMP is to extend the range in coverage. The range extension improved from an average of 230 km to 250 km when the site is operating well. The site must be properly tuned in order to accurately measure the phase offset between the two transmit antennas in order to get the maximum range extension possible. The next page shows the comparison in coverage before and after (respectively) the dual transmit install and phase offset measurements were completed.

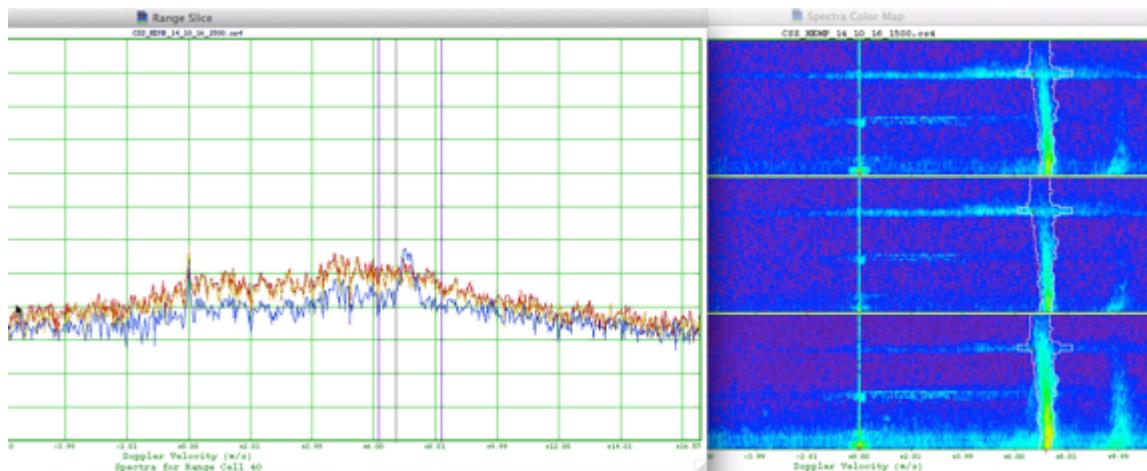
The one issue we've encountered with the dual transmit upgrade is the potential for more interference from other sites transmitting at the same frequency. When such bistatic interference occurs, it can potentially be processed as first order Bragg scatter (as shown in the figure below) and it is often evident with the appearance of strong, anomalous vectors. The bistatic interference seen at HEMP is commonly found in range cells 40 and 41 (shown below). We are working with CODAR to set the GPS alignments properly to improve timing and reduce the interference.

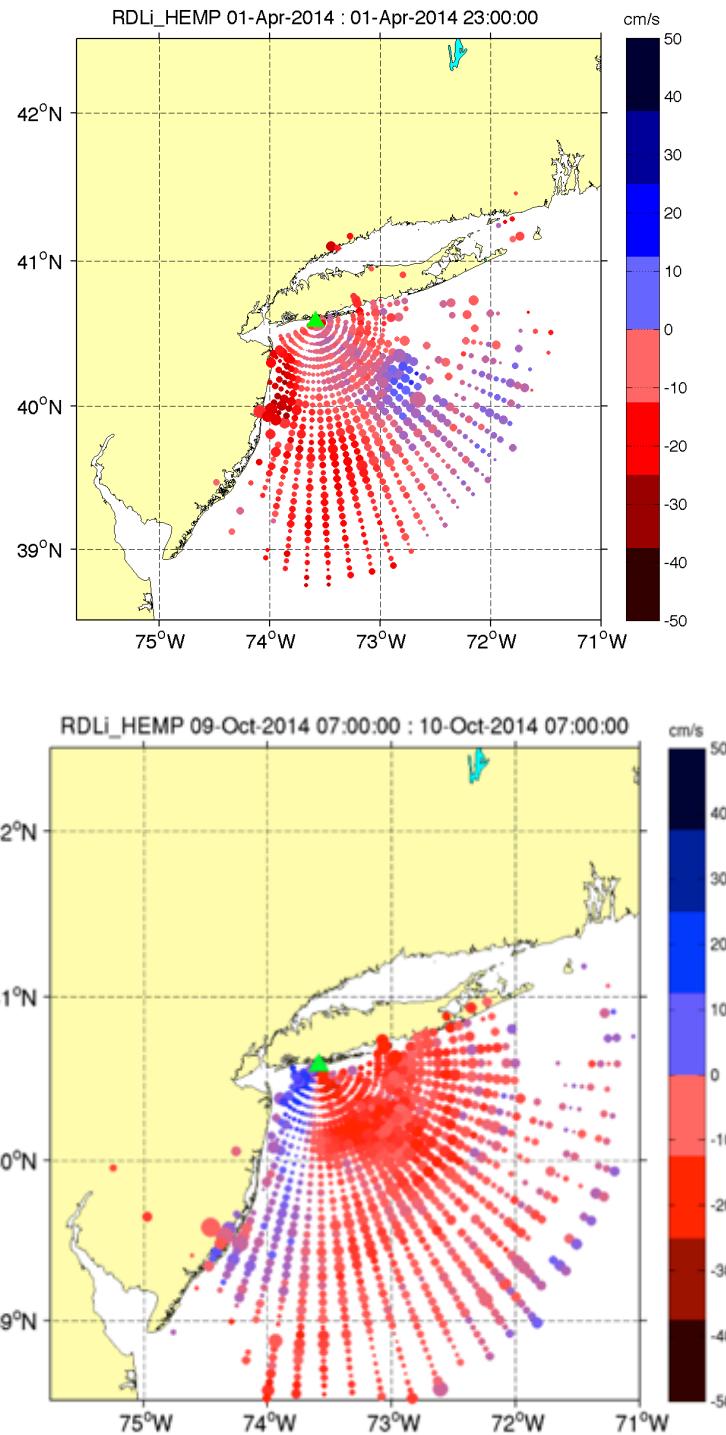
The standard deviation for each radial vector was calculated and plotted below before and after the dual transmit upgrade, respectively

The plots show the average radial velocities (color bar) associated with the standard deviation (size of dot) for each range and bearing. The color scheme indicates whether the vector is moving toward (blue) or away (red) from the radar. A smaller dot indicates a lower standard deviation and a higher standard deviation is represented by a larger dot. One of the advantages of having a dual transmit system is the consistent coverage in range cells 200-230 km offshore. These were once the very outer range

cells for the normal long-range HEMP site and, depending on the sea-state, would typically show high standard deviations. It is not uncommon to lost coverage in the last few range cells where the signal does not always propagate out that far, but with the installation of the second transmit unit there is consistent coverage because of the extended radar signal.

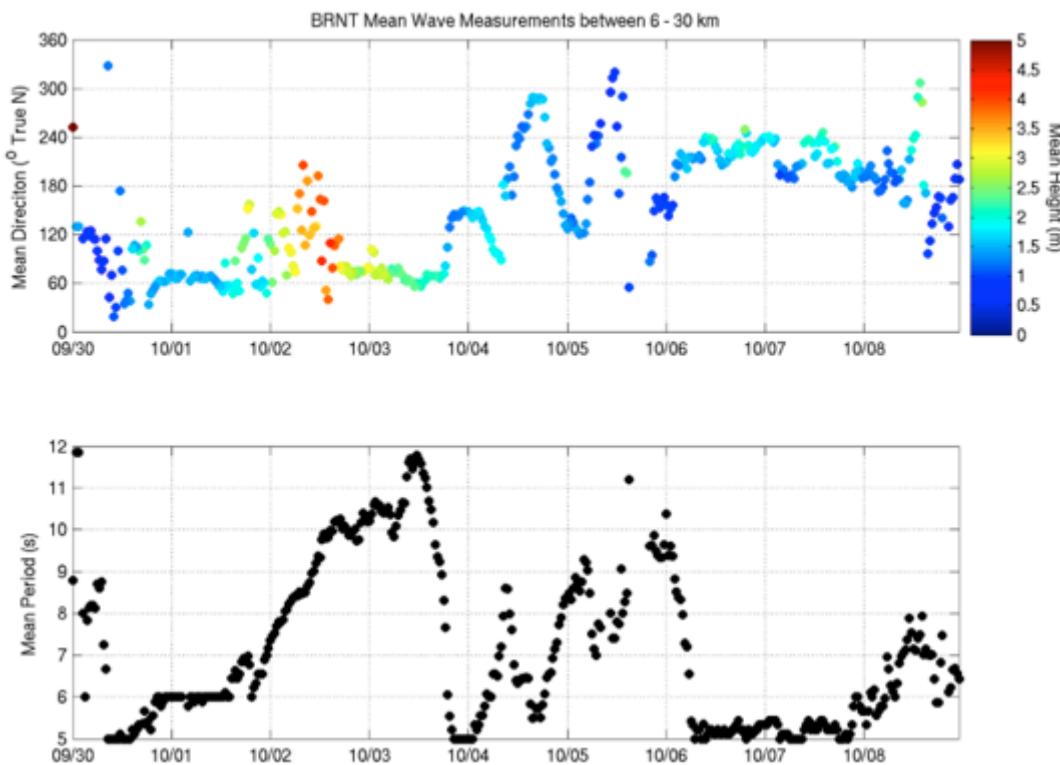
Wave height, direction, and period can be depicted from second order Bragg measured by the radar. Below is an example of a time series plot from a mid-range site located in Brant Beach, NJ (BRNT):

The range in wave measurements varies depending on how far the second order Bragg extends off shore. These plots will be improved in future analysis to clearly display if shallow water in the closer range cells is affecting the data. Rutgers is working on programming a 3D animation to display wave height measurements overlaid on top of a bathymetry map, along with improvement in the time series plots.

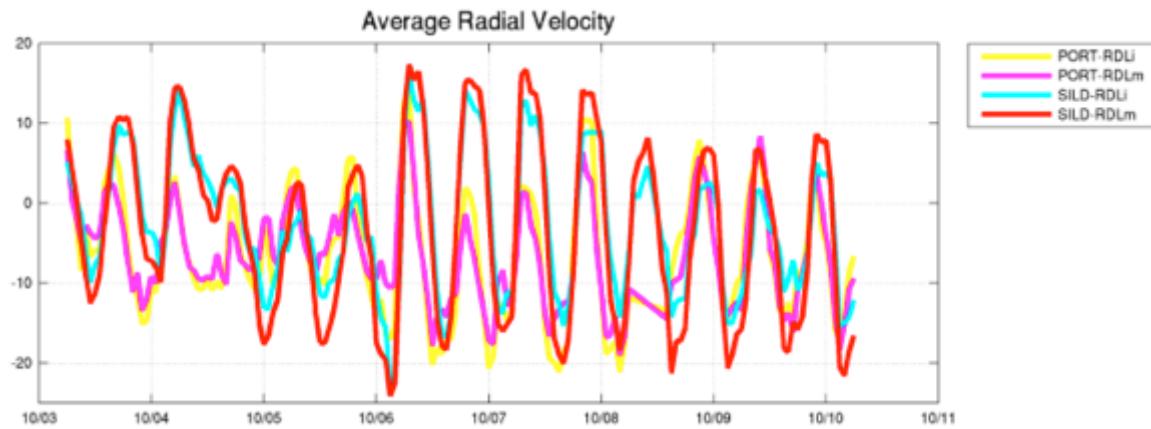
Average radial velocity and radial vector count plots are generated hourly as a method of quality control. If the radar is operating efficiently, the M2 tide should be clearly represented by the semidiurnal peaks in the hourly-averaged radial velocities. Below shows the latest time series plot displaying the average radial velocity for each hour for the New York Harbor standard-range sites in Staten Island, NY (SILD) and Port Monmouth, NJ (PORT):

Here we see 12-hour peaks in the radial velocity hourly average but there are times where the peak is much lower in magnitude at PORT than SILD. There are also times where there is no clear, distinct peak. When this happens, it is necessary to analyze the data at the spectra level and examine the first order line settings.

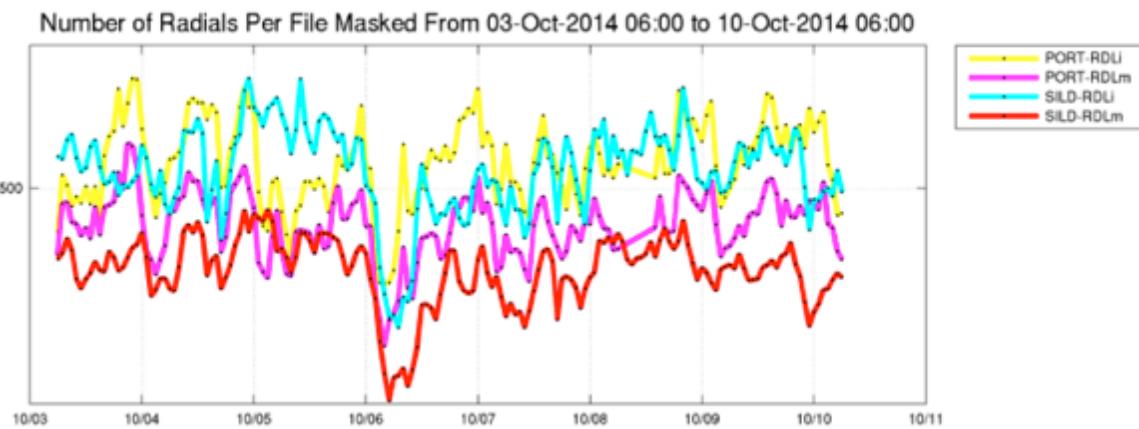
Time series plots are generated for radial vector count at each hour. There are a few reasons these plots are helpful in QA/QC. If the radar is continuously generating radial files with low vector counts, the first check is to examine whether there is Bragg on all three antennas. If there is evidence of Bragg scattering, then the reason for the low radial vector count is most likely software related, notably the first order line settings in the configurations folder. The latest time series for the New York Harbor sites is displayed on the next page:

From the above plot, it is clear that the measured radial file size was at one point extremely low for the 25 MHz site SILD (Staten Island, NY) on October 6th, 2014. Spectra files for that time period were analyzed using the SpectraPlotterMap software application, written by CODAR Ocean Sensors. Below is a screenshot of a spectra file on October 6th, 2014 using the “blackout” option to clearly outline what was processed as first order Bragg.

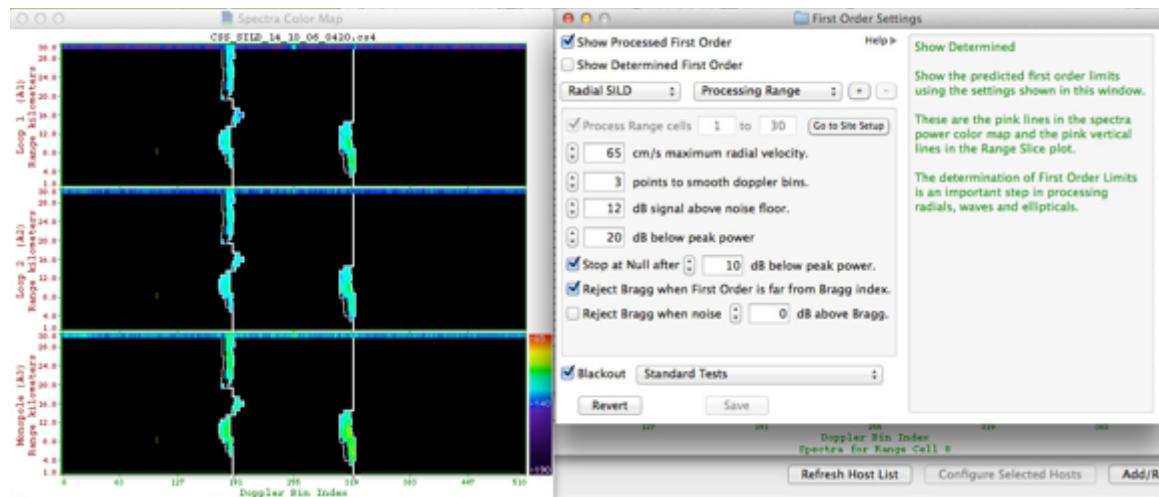
The first order lines were too constrictive for capturing the Bragg scattered signal reflected off of the surface gravity waves, which would explain the small radial files sizes for that time period.

The next step is to adjust the first order lines so that they are not too constrictive and not too wide for more accurate processing. In this particular case with SILD, it is a difficult environment to determine what constitutes as first order Bragg since there appears to be some evidence of second order saturation but nonetheless, much of the Bragg return is not getting processed. It was determined that three options in the first order configuration settings needed to be adjusted: maximum radial velocity, signal

above noise floor, and peak power drop-off. The changes made in the settings are displayed in the table below:

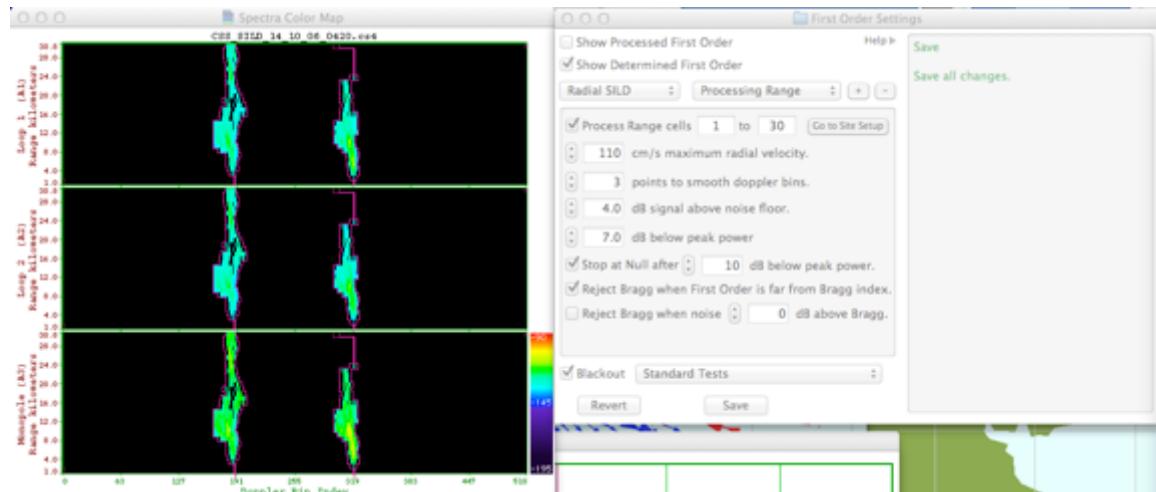
The changes implemented in the FOL configuration at SILD improved the radial coverage in the New York Harbor. The same spectra from October 6th, 2014 shown above is displayed on the next page with the FOL changes:

Again, SILD is an interesting site when it comes to first order processing because of the unique environment. CODAR and Rutgers have discussed FOL changes since there seems to be “split” Bragg peaks past range cell 12. The new first order processing settings do a better job capturing the Bragg peaks, which increased the radial vector count in the reprocessed radial files.

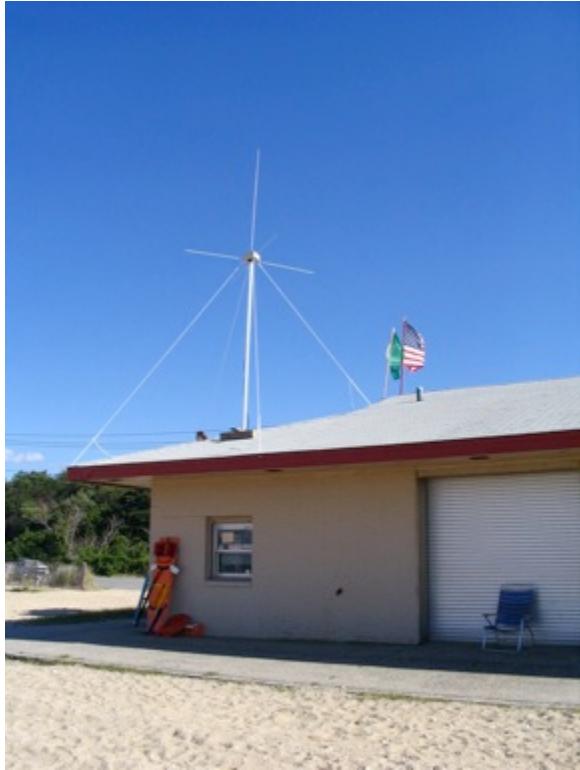
4. Stehli Beach, NY

Stehli Beach upgrades are almost complete. The machine shop is fabricating a new antenna mount that will be installed on a roof. Once this is complete the new antenna will be installed at Stehli beach. All other equipment installation has been done at Stehli. Great Captain will be installed soon. The Island caretaker needs to be available with his onsite equipment to transport the equipment from the dock over the beach to the building site of the current installation. Block Island and Misquamicut have all the new hardware installed. Block Island communications are currently down. A repair technician has fixed the issue as of 10/13/2014. A trip is being planned to configure the communications. Misquamicut communications are also down. A trip is being planned for 10/16/2014 to configure the communications there as well. Montauk will receive a new air conditioner to finalize the hardening at that site. The current installation of all 5 sites is detailed in the images below
